MISCELLANEOUS PAPER S-73-5

RAPID ROAD CONSTRUCTION USING MEMBRANE-ENVELOPED SOIL LAYERS

A. H. Joseph, R. D. Jackson, S. L. Webster

February 1973

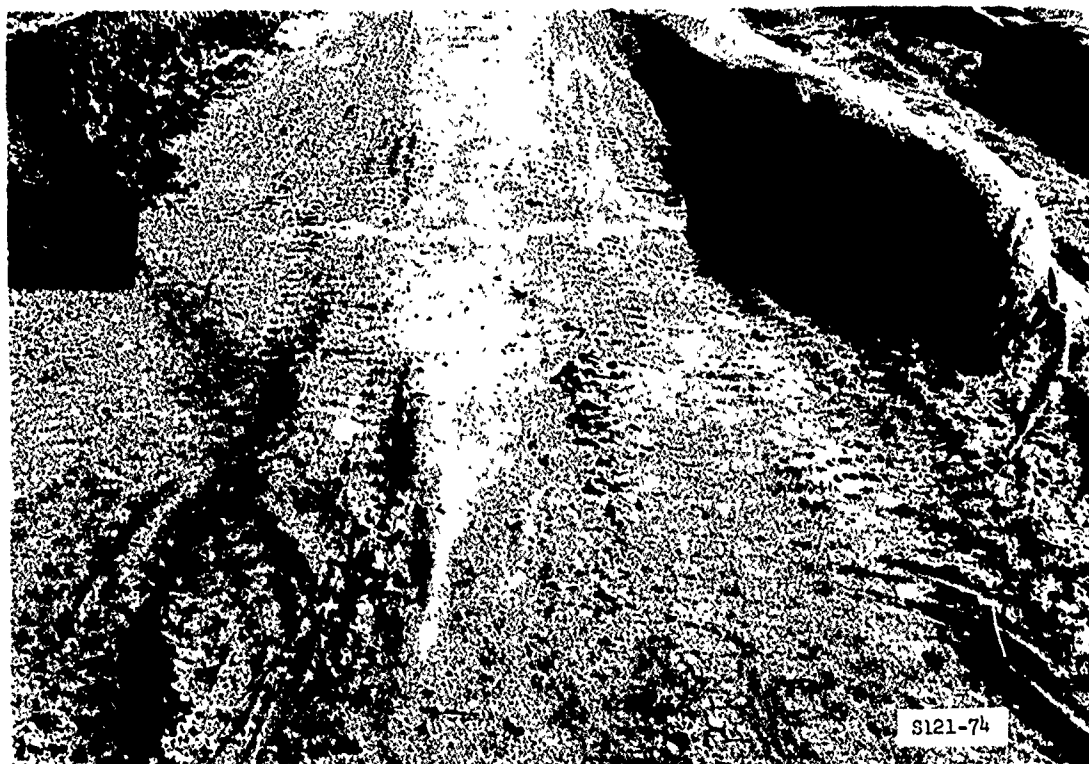
39. Items 3 and 4. Photos 27 and 28 show item 3 after 36 coverages and item 4 after 348 coverages, respectively. Complete failure had occurred in the outside wheel path of item 3 after only 36 coverages. Item 4 withstood 348 coverages before sustaining the same type failure.

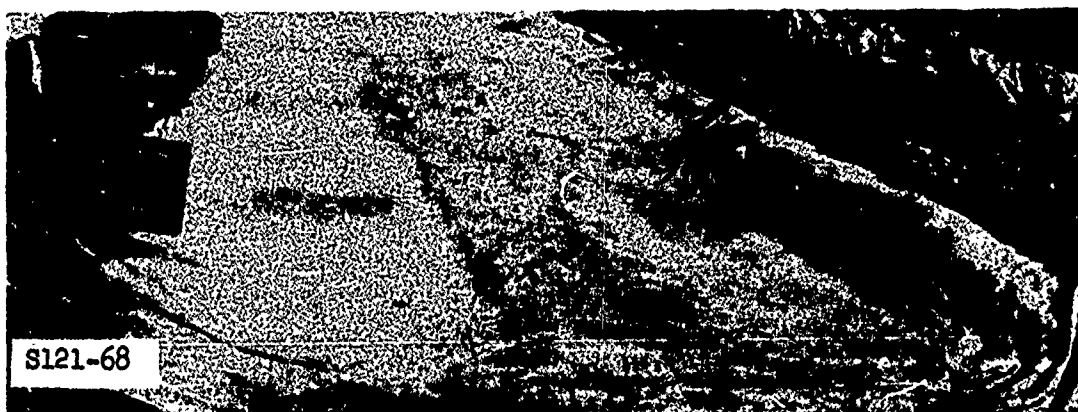
44. Item 9. This item is shown in photo 33 after 450 coverages. Failure occurred along the outside wheel path over about one-half of the length of the item.

Photo 33. Item 9 after 450 coverages under flooded-lane test conditions
